Davis Creek Watershed Report Card

Davis Creek Subwatershed Legend

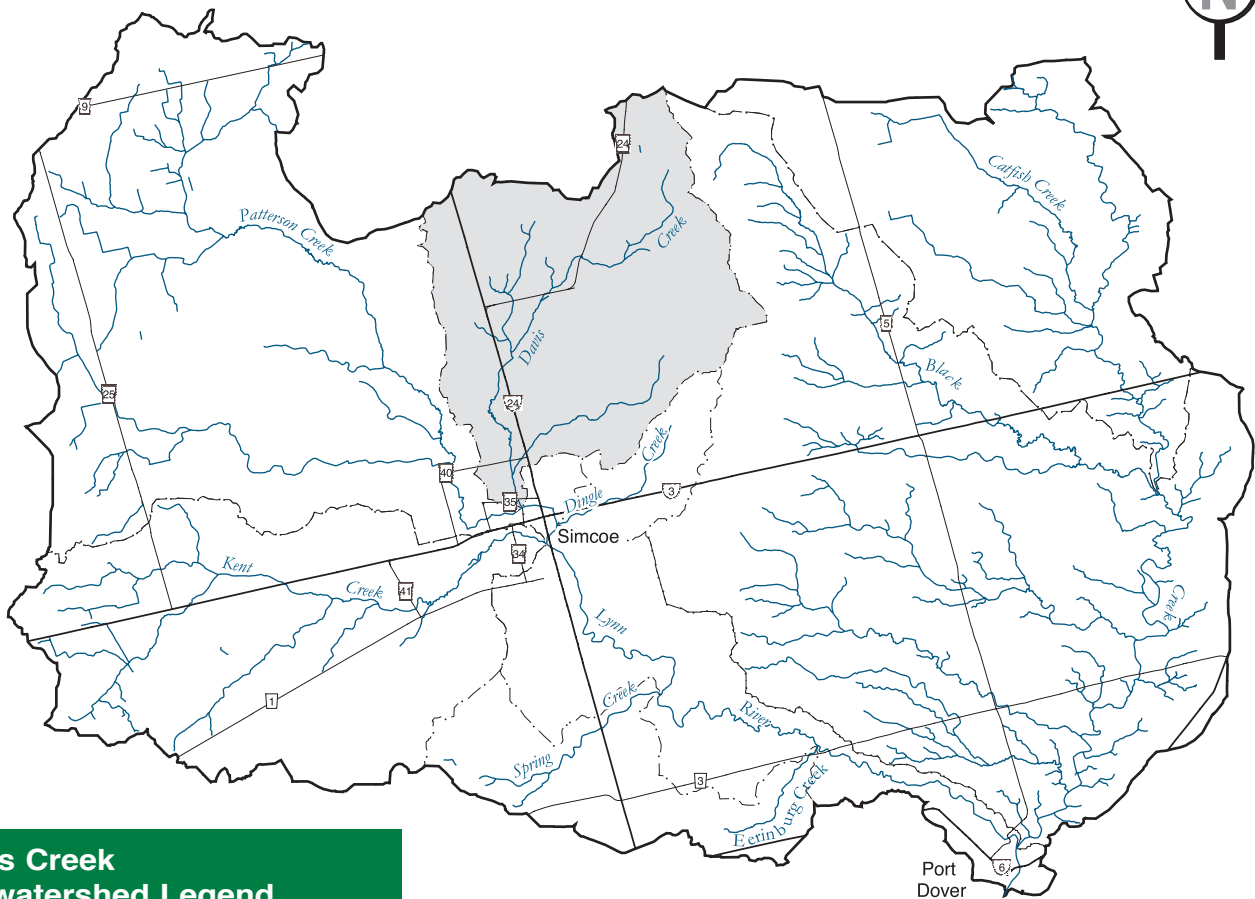
- Water Course
- Surrounding Watershed
- County Road
- Study Subwatershed
- Provincial Road
- Lynn River & Black Creek Watershed
